Manhole Inspection Summary

Manhole # S57CC_004MH

Insp Date: **6/5/08 1:36 PM**

Location Address: **kresson**

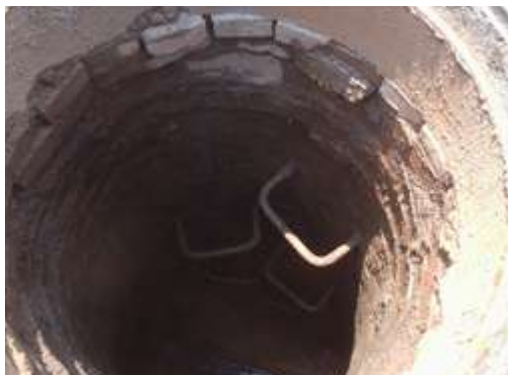
Defect 1

Condition: ☐ Sound ☐ Cracked ☐ Root Intrusion ☒ **Loose Brick** ☐ Deteriorated

Infiltration: ☐ None ☐ Joint ☐ Cracks ☒ **Mortar** ☐ Roots ☐ Wall

Loose bricks, Infiltration

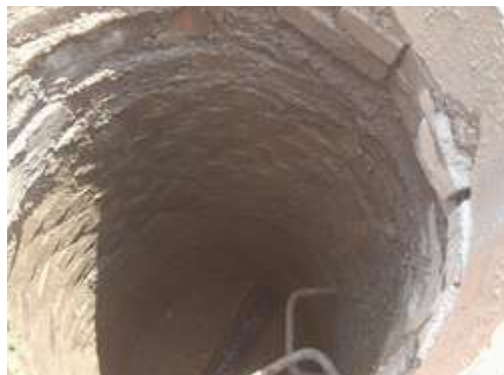
Defect 2

Loose bricks, Infiltration

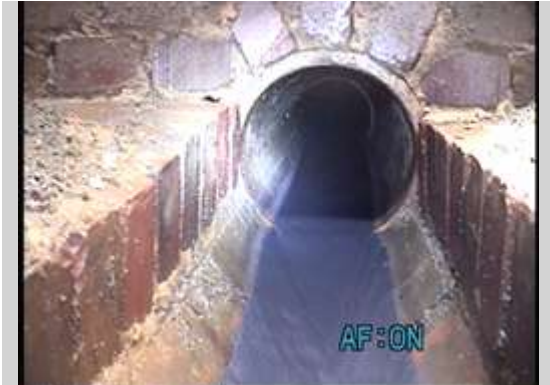
8 in. Circular Gravity Sewer
Pipe Out @ 12 O'Clock

Pipe Height: **8.4** (in.) Rod and Bar (Angled)
Pipe Material: **Clay** ☐ Pipe Lined
Invert Depth: **11.00** (ft.) Flow Characteristics: **Fast**
Deposits: ☒ None ☐ Mud ☐ Sludge ☐ Debris ☐ Grease
Silt Depth: (in.) Deposits Extent:
Infiltration: **None** Pipe Seal Cond: **Sound**
